## Troubleshooting the P0108 DTC Fault in Suzuki XL7 Engines

*This study aims to describe the analysis of the causes of problems in the engine of Suzuki XL7 with Diagnostic Trouble Code P0108. The analysis was conducted to identify the causes of this problem in the engine. This study used a quantitative descriptive approach, evaluating engine data through scan tool, multimeter, and vacuum gauge testing. The testing procedure included engine preparation, instrument calibration, and the execution of diagnostics in accordance with established standard procedures. The research results indicate that the cause of the problem lies in the internal circuit of the MAP (manifold absolute pressure) sensor, with an O.L. (open-loop) measurement result, indicating no connection. This result was obtained by analysing the connections within the entire internal circuit of the MAP sensor. Overall, this study provides empirical information regarding the functioning of the MAP sensor in relation to the engine performance of the Suzuki XL7 following measurement analysis conducted in accordance with applicable procedures.*

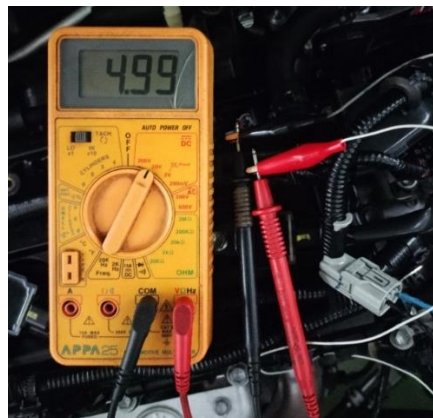
[Figure 3](#). MAP Sensor Power Supply Voltage

The measurement results are in accordance with the specifications; the MAP sensor power supply is approximately 5 V, as shown in [Figure 3](#).

| No | Parameter | Value (unit) | Specification | Analysis |
|---|---|---|---|---|
| 1 | MAP circuit power supply | 4,99 Volt | Approx 5 Volt | Good |

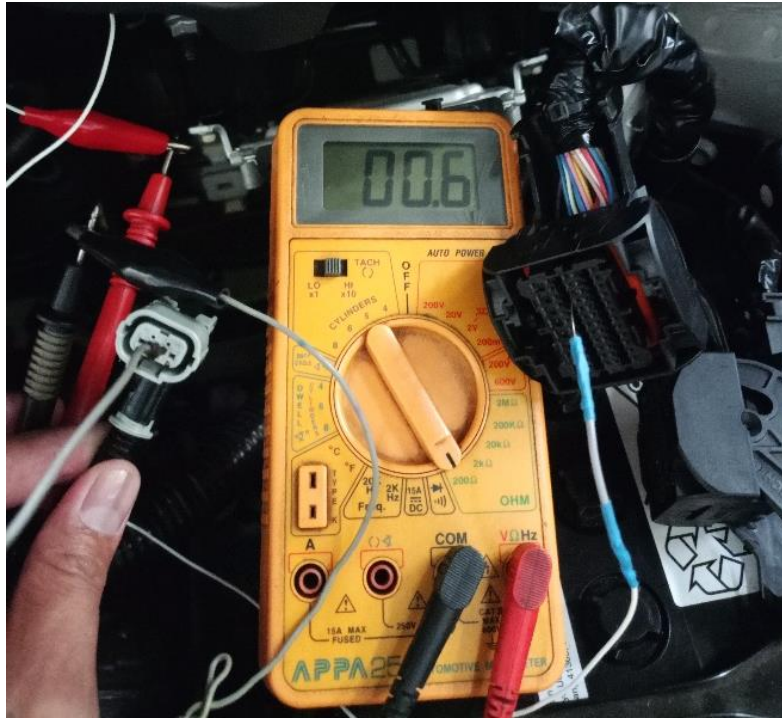
Figure 4. Circuit A2 Resistance

#### 3.2.2.1 Circuit A2 resistance result $0.6\ \Omega$ as shown in Figure 4.

| No | Parameter | Value (unit) | Specification | Analysis |
|---|---|---|---|---|
| | a. A2 circuit resistance | 0,6 $\Omega$ | $\leq 1 \Omega$ | Good |

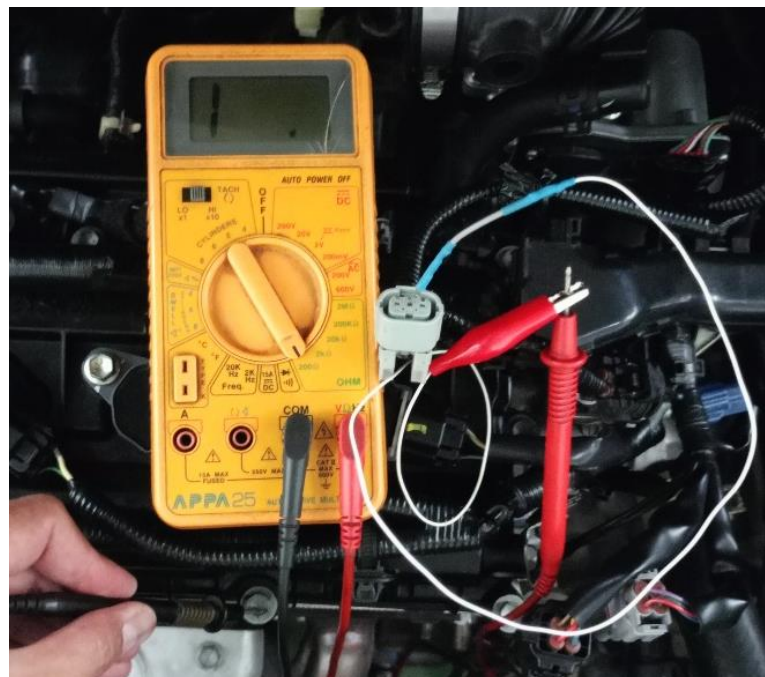
Figure 5. Circuit A2 Resistance With Ground

#### 3.2.2.2 Circuit A2 resistance with ground O.L as shown in Figure 5.

| No | Parameter | Value (unit) | Specification | Analysis |
|---|---|---|---|---|
| | b. A2 circuit resistance with ground | O.L | O.L | Good |

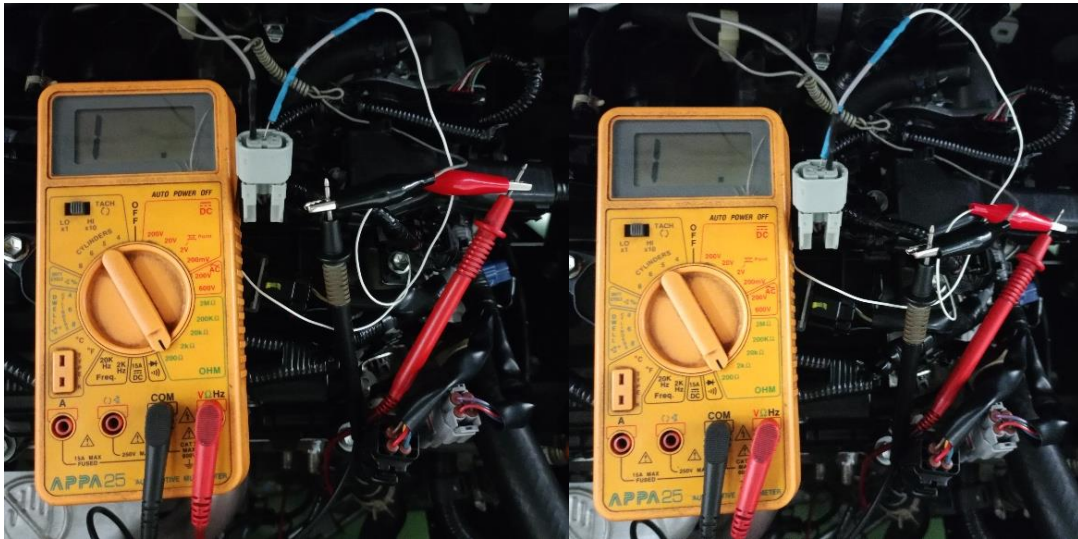
Figure 6. Circuit A2 resistance with other circuit

3.2.2.3 Circuit A2 resistance with other circuit is O.L, as shown in Figure 6.

| No | Parameter | Value (unit) | Specification | Analysis |
|---|---|---|---|---|
| 2 | c. A2 circuit resistance with other circuit in MAP connector | O.L | O.L | Good |

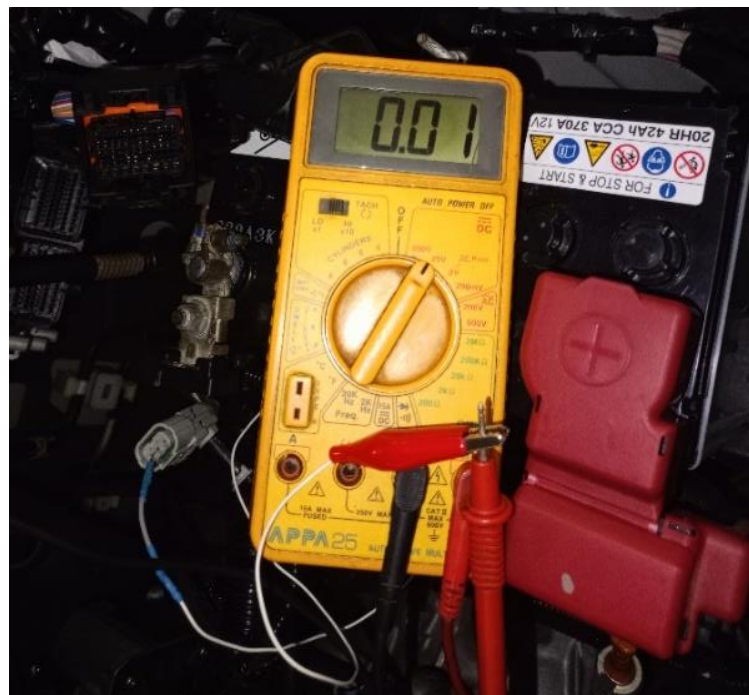
Figure 7. Circuit A2 voltage

3.2.2.4 Circuit A2 Voltage as Shown in Figure 7.

| No | Parameter | Value (unit) | Specification | Analysis |
|---|---|---|---|---|
| | d. A2 circuit voltage (IG ON) | 0 Volt | Approx 0 Volt | Good |

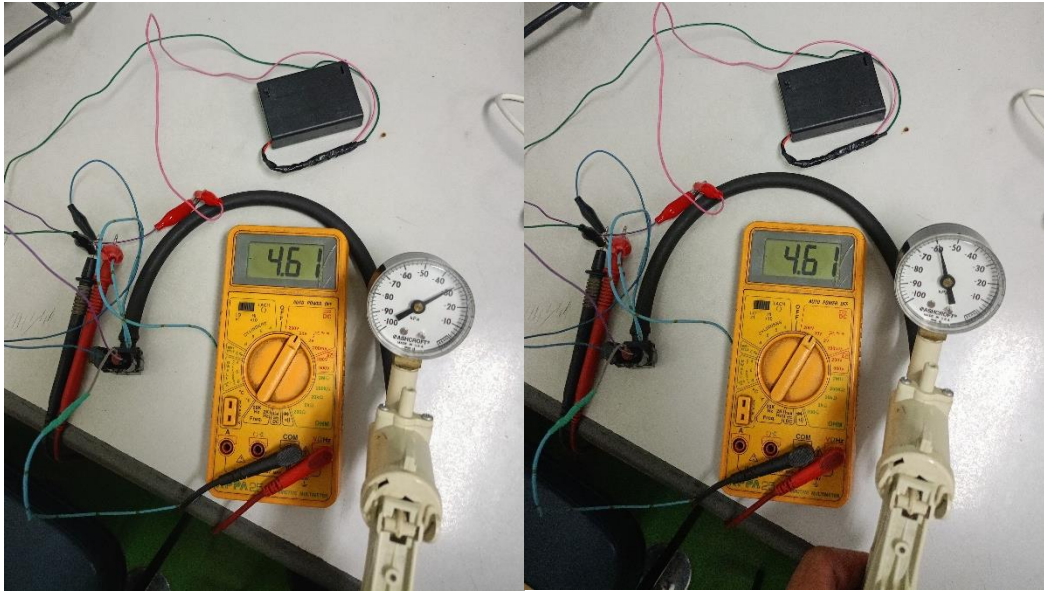
Figure 8. MAP sensor performance check

Measuring result of MAP sensor is 4,61 Volt and not suitable with specification as shown in Figure 8.

| No | Parameter | Value (unit) | Specification | Analysis |
|---|---|---|---|---|
| 3 | a. Negative pressure (-30 kPa) | Approx 4,61 Volt | Approx 2,9 Volt | Bad |
| | b. Negative pressure (-60 kPa) | Approx 4,61 Volt | Approx 1,7 Volt | Bad |

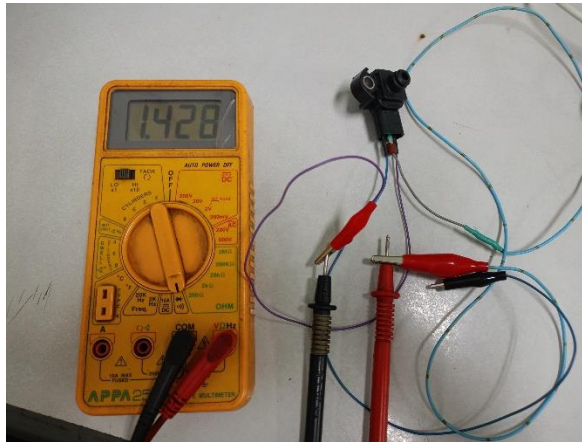
[Figure 10](#). A1 and A2 connection

3.3.2 A1 and A2 connection as shown in [Figure 10](#).

| No | Parameter | Value (unit) | Specification | Analysis |
|---|---|---|---|---|
| 4 | a. A1 and A2 | Connected | Connected | Bad |

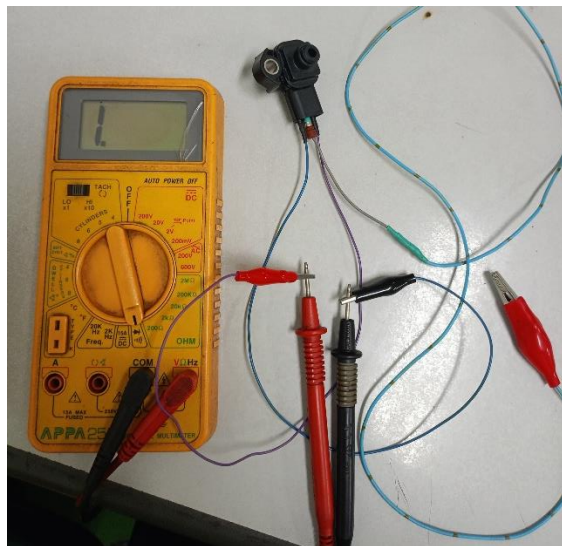
[Figure 11](#). A1 and A3 connection

3.3.3 A1 and A3 connection as shown in [Figure 11](#).

| No | Parameter | Value (unit) | Specification | Analysis |
|---|---|---|---|---|
| | c. A1 and A3 | O.L | Connected | Bad |

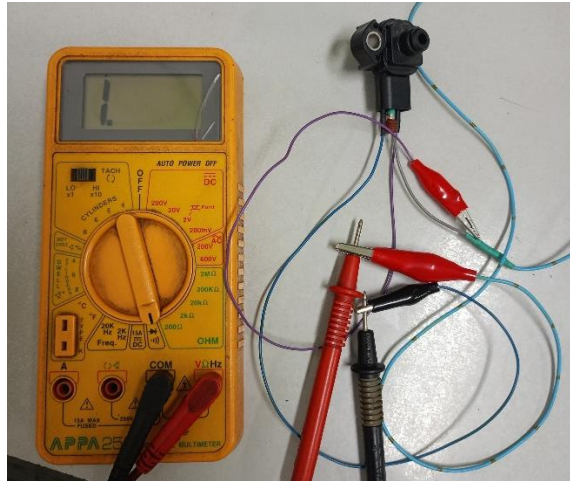
Figure 12. A2 and A3 connection

3.3.4 A2 and A3 connection as shown as in [Figure 12](#).

| No | Parameter | Value (unit) | Specification | Analysis |
|---|---|---|---|---|
| | b. A2 and A3 | O.L | Connected | Bad |

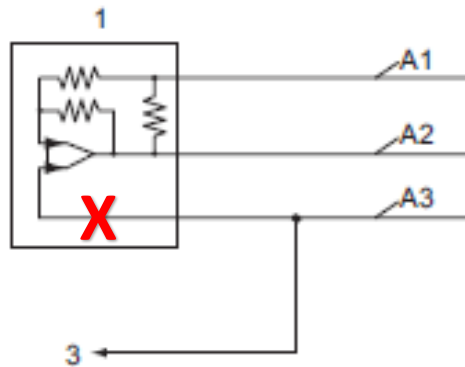
Figure 13. Internal circuit of the MAP sensor is open

The results of the final inspection of the internal MAP circuit connections shows that there are no connections to A3.

The results show that neither circuit (A1 nor A2) is not connected to A3 as a ground circuit. According to the reference in Figure 9. MAP Circuit Diagram, these circuits should be connected. It can therefore be concluded that there is a fault within the MAP circuit, namely that the internal circuit of the MAP sensor is open as shown in Figure 13. marked with a red X.
