## Troubleshooting the P0108 DTC Fault in Suzuki XL7 Engines

*This study aims to describe the analysis of the causes of problems in the engine of Suzuki XL7 with Diagnostic Trouble Code P0108. The analysis was conducted to identify the causes of this problem in the engine. This study used a quantitative descriptive approach, evaluating engine data through scan tool, multimeter, and vacuum gauge testing. The testing procedure included engine preparation, instrument calibration, and the execution of diagnostics in accordance with established standard procedures. The research results indicate that the cause of the problem lies in the internal circuit of the MAP (manifold absolute pressure) sensor, with an O.L. (open-loop) measurement result, indicating no connection. This result was obtained by analysing the connections within the entire internal circuit of the MAP sensor. Overall, this study provides empirical information regarding the functioning of the MAP sensor in relation to the engine performance of the Suzuki XL7 following measurement analysis conducted in accordance with applicable procedures.*

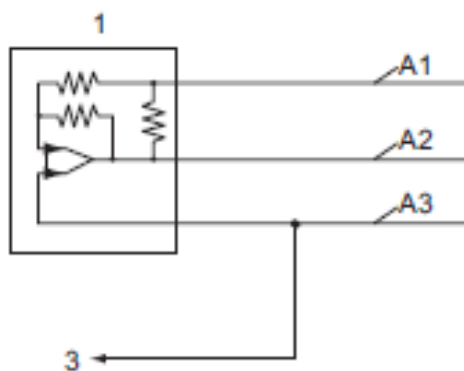
Figure 9. MAP Circuit Diagram

As the results of the MAP sensor performance check revealed that it is not suitable with the specification. The final analysis is required, need to check the internal circuit of the MAP sensor. Continuity measurements are frequently conducted during the troubleshooting process to verify the integrity of the electrical lines [14]. A continuity tester is used to determine the presence of an electrical path between two points in a circuit [15]. Check the internal circuit by referring to Figure 9.

The results of the final inspection of the internal MAP circuit connections shows that there are no connections to A3.

The results show that neither circuit (A1 nor A2) is not connected to A3 as a ground circuit. According to the reference in Figure 9. MAP Circuit Diagram, these circuits should be connected. It can therefore be concluded that there is a fault within the MAP circuit, namely that the internal circuit of the MAP sensor is open as shown in Figure 13. marked with a red X.
